**Flood Control Project Maintenance  
Levee Inspections**  
**LMA District Cover Sheet**  
**Spring 2019 Levee Inspection Results**

**Reclamation District No. 0003 Grand Island**

**Spring 2019 Levee Inspection Results**

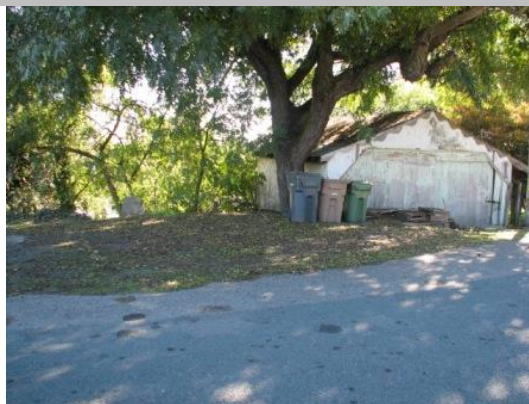
Photo 1 of 1 : SP\_2019\_RD0003\_24\_74\_20190311\_00066.jpg

LM Start	7.63	Rating **	U	Issue No.	74
LM End	7.63	Issue Type +	En	Location *	LS
Category	Earthen Levee			GPS Latitude/Longitude	
				Start	End
Item	Encroachments			38.207666 °	38.207666 °
				-121.609327 °	-121.609327 °
DWR ID	DWR_RD0003_01_s_2012_74				
Comment Code					
BU : Building					
Inspector Comment					
Buildings obstruct access and visibility of the levee slope and toe.

View of building on the landside slope.

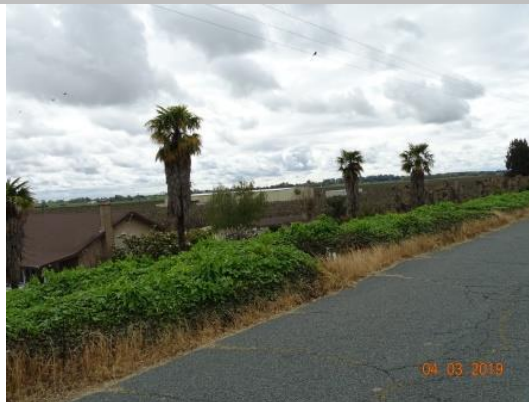
Photo 1 of 1 : SP\_2019\_RD0003\_24\_91\_20190403\_00174.jpg

LM Start	7.74	Rating **	M	Issue No.	91
LM End	7.76	Issue Type +	En	Location *	LS
Category	Earthen Levee			GPS Latitude/Longitude	
				Start	End
Item	Vegetation			38.206207 °	38.205813 °
				-121.609606 °	-121.609607 °
DWR ID	DWR_RD0003_01_s_2018_91				
Comment Code					
V6 : Landscaping					
Inspector Comment

View looking downstream at landscape vegetation on the landside slope  
(Spring 2019).

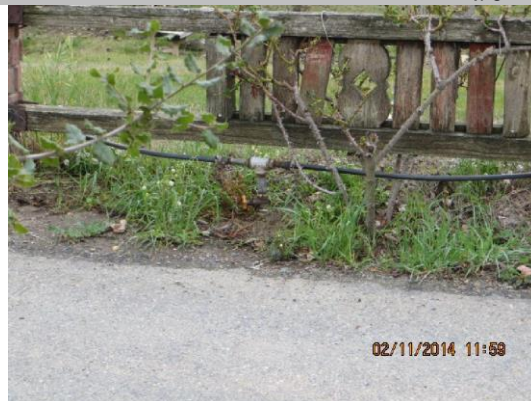
Photo 1 of 3 : UCIP\_SP\_2019\_31283\_57282.jpg

LM Start	7.76	Rating **	M	Issue No.	208	
LM End	7.76	Issue Type +	En	Location *		
Category	Supplemental			GPS Latitude/Longitude		
				Start	End	
Item	DWR UCIP Field Study			38.205846 °	38.205846 °	
				-121.609574 °	-121.609574 °	
DWR ID	24836					
Comment Code						
Inspector Comment						
FS_ID:31283 DS_ID:24836 EP_NO: N/A Repair Type: Non-Urgent Crossing Status: Found UCIP Comments: No permit identified for this crossing. FIELD_STRUCT_DESC: 2.5-inch galvanized iron irrigation pipe through the levee, at an unknown depth. Pipe and spigot visible at the waterside (WS) toe. A second spigot on the landside (LS) slope. This crossing was field discovered. FS Date: 2/11/2014

Shutoff valve next to LS ramp

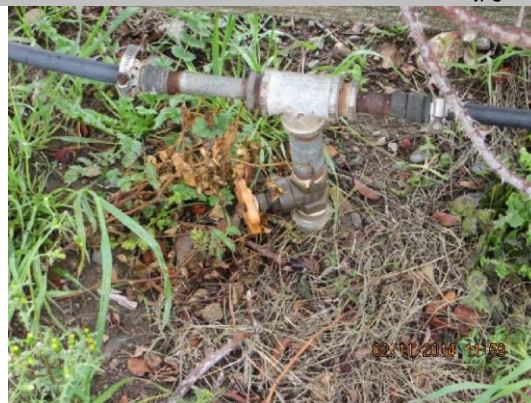
Photo 2 of 3 : UCIP\_SP\_2019\_31283\_57281.jpg

Shutoff valve next to LS ramp

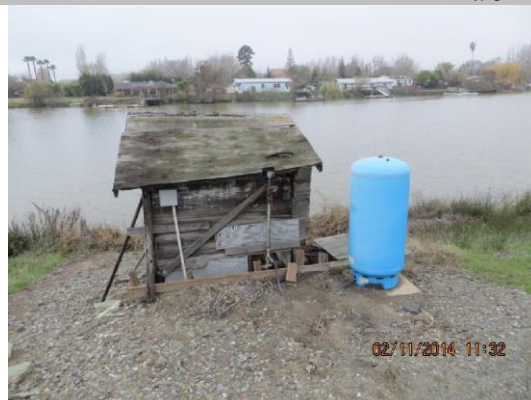
Photo 3 of 3 : UCIP\_SP\_2019\_29235\_54051.jpg

Comment Code						
Inspector Comment						
FS_ID:29235 DS_ID:22186 EP_NO: 2225 Repair Type: Non-Urgent Crossing Status: Found UCIP Comments: CMP riser knocked over and no sign of siphon breaker. FIELD_STRUCT_DESC: 8-inch steel irrigation discharge pipe through the levee, invert elevation 3.5 feet below the crown. Service pole and siphon breaker in a corrugated metal pipe (CMP) riser on the landside (LS) slope. Pump in a pump house and a booster pump on a concrete slab on the waterside (WS) slope. (Plans to install an 8-inch irrigation pipe through the levee and an inclined pump on the WS slope authorized under Permit No. 2225, 1955 - Fay Ranch, Captain N. A. Fay, care of The River Lines, Inc. USACE Unit No. 10, new pipe installed in 1967). [Additional Reference(s): DWR Levee Log, 1993. USACE Sacramento O&M Manual 104, February 1960, (17.92)]. FS Date: 2/11/2014

Pump and tank on WS shoulder.

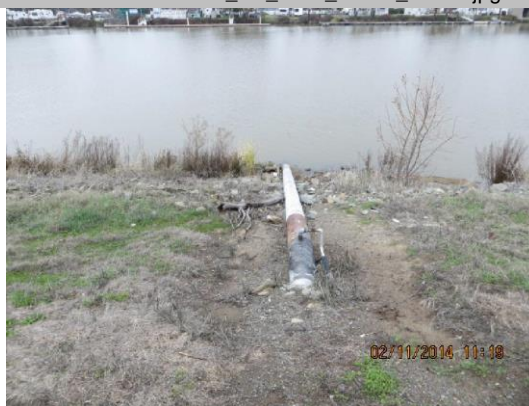
Photo 1 of 3 : UCIP\_SP\_2019\_29233\_54047.jpg

Comment Code					
Inspector Comment					
FS_ID:29233					
DS_ID:22187					
EP_NO: N/A					
Repair Type: Non-Urgent					
Crossing Status: Found					
UCIP Comments: Siphon breaker and CMP riser missing from LS slope.					
FIELD_STRUCT_DESC: 12-inch steel irrigation siphon through the					
levee, invert elevation 3.5 feet below the crown. Primer pump in a pump					
house and a siphon breaker in a corrugated metal pipe (CMP) riser on					
the landside (LS) slope. 48-inch concrete standpipe at the LS toe.					
(USACE Unit No. 10, new pipe installed in 1967). [Additional					
Reference(s): DWR Levee Log, 1993. USACE Sacramento O&M					
Manual 104, February 1960, (RM 17.79)].					
FS Date: 2/11/2014

Pipe visible on WS slope.

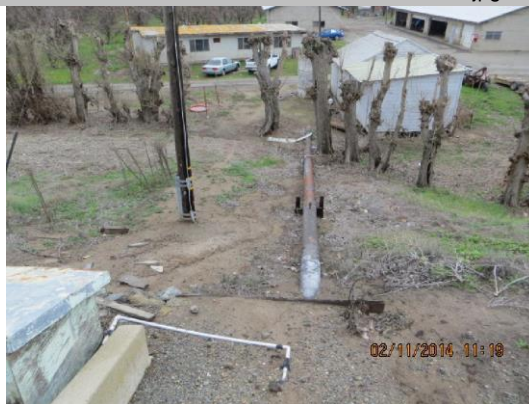
Photo 2 of 3 : UCIP\_SP\_2019\_29233\_54046.jpg

Pipe, pumphouse, and standpipe visible on LS slope.

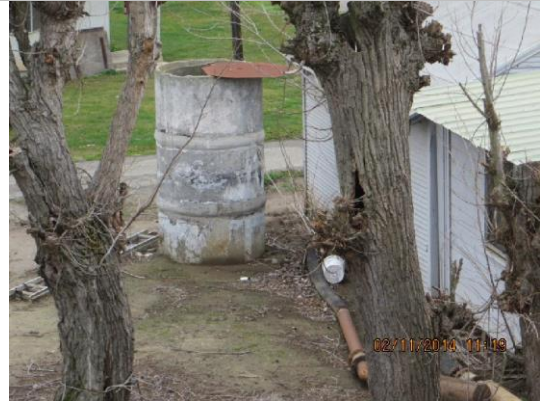
Photo 3 of 3 : UCIP\_SP\_2019\_29233\_54045.jpg

Comment Code						
Inspector Comment						
FS_ID:29233 DS_ID:22187 EP_NO: N/A Repair Type: Non-Urgent Crossing Status: Found UCIP Comments: Siphon breaker and CMP riser missing from LS slope. FIELD_STRUCT_DESC: 12-inch steel irrigation siphon through the levee, invert elevation 3.5 feet below the crown. Primer pump in a pump house and a siphon breaker in a corrugated metal pipe (CMP) riser on the landside (LS) slope. 48-inch concrete standpipe at the LS toe. (USACE Unit No. 10, new pipe installed in 1967). [Additional Reference(s): DWR Levee Log, 1993. USACE Sacramento O&M Manual 104, February 1960, (RM 17.79)]. FS Date: 2/11/2014

Concrete standpipe on LS toe.

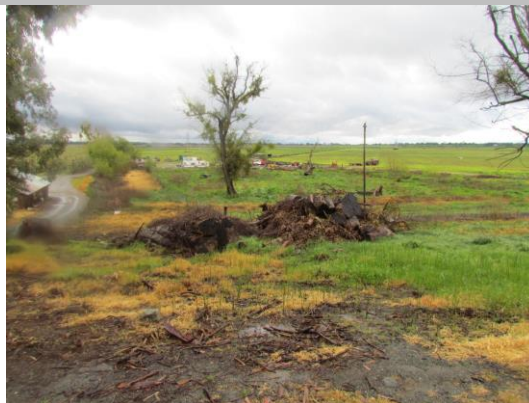
Photo 1 of 1 : SP\_2019\_RD0003\_24\_59\_20190311\_00045.jpg

LM Start	8.88	Rating **	M	Issue No.	59
LM End	8.88	Issue Type +	En	Location *	LS
Category	Earthen Levee			GPS Latitude/Longitude	
				Start	End
Item	Encroachments			38.193217 °	38.193217 °
				-121.620050 °	-121.620050 °
DWR ID	DWR_RD0003_01_s_2017_59				
Comment Code					
PR : Prunings					
Inspector Comment					
Pruning pile on the landward slope needs to be removed.

Looking east at pruning piles on landward berm.

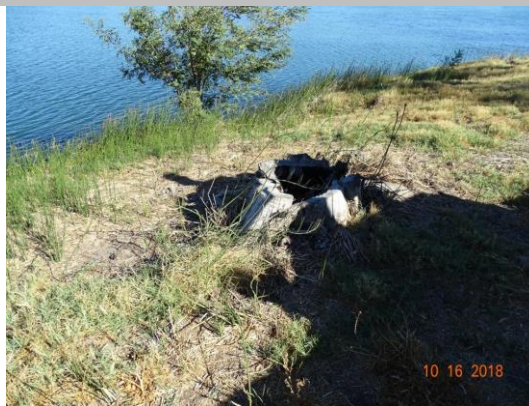
Photo 1 of 1 : SP\_2019\_RD0003\_24\_39\_20190311\_00026.jpg

LM Start	8.92	Rating **	U	Issue No.	39
LM End	8.92	Issue Type +	Ma	Location *	WS
Category	Earthen Levee			GPS Latitude/Longitude	
				Start	End
Item	Trim / Thin Trees			38.193000 °	38.193000 °
				-121.620700 °	-121.620700 °
DWR ID	DWR_RD0003_01_f_2018_39				
Comment Code					
T5 : Tree stumps.					
Inspector Comment					
Remove the rotting tree stump.

View of rotting tree stump on water side crown (October 2018).

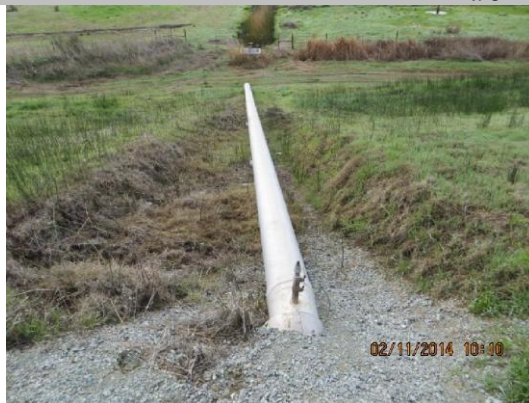
Photo 1 of 3 : UCIP\_SP\_2019\_29187\_53952.jpg

Comment Code					
Inspector Comment					
FS_ID:29187 DS_ID:22202 EP_NO: N/A Repair Type: Non-Urgent Crossing Status: Found UCIP Comments: Annular space between 12 and 14-inch pipes not grouted. FIELD_STRUCT_DESC: 14-inch steel irrigation siphon through the levee, invert elevation 2.9 feet below the crown. 14-inch pipe sleeved with a 12-inch pipe. Vent and siphon breaker on the landside (LS) shoulder. Concrete distribution box and gate valve at the LS toe. [Additional Reference(s): DWR Levee Log, 1993, referenced as a 16-inch pipe sleeved with a 12-inch pipe. USACE Sacramento O&M Manual 104, February 1960, (RM 16.92), referenced as a 16-inch pipe sleeved with a 14-inch pipe]. FS Date: 2/11/2014 11:00:22 AM

Pipe, siphon breaker/vent, and distribution box visible on LS.

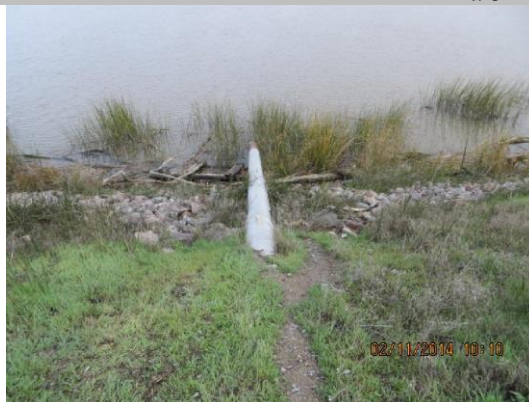
Photo 2 of 3 : UCIP\_SP\_2019\_29187\_53951.jpg

Pipe visible on WS slope.

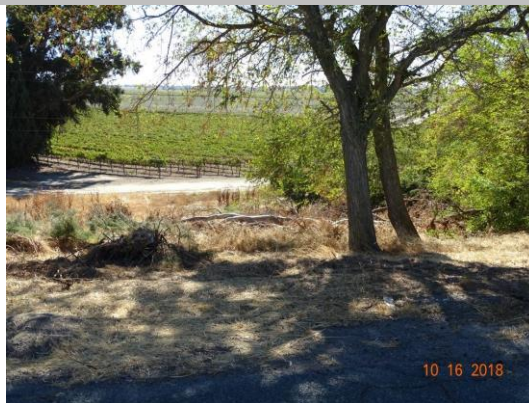
Photo 1 of 1 : SP\_2019\_RD0003\_24\_95\_20190311\_00081.jpg

LM Start	10.14	Rating **	M	Issue No.	95
LM End	10.14	Issue Type +	En	Location *	LS
Category	Earthen Levee			GPS Latitude/Longitude	
				Start	End
Item	Encroachments			38.188424 °	38.188424 °
				-121.641517 °	-121.641517 °
DWR ID	DWR_RD0003_01_s_2018_95				
Comment Code					
TR : Tree or limb					
Inspector Comment					
Remove tree limbs from the landside slope.

View of tree limbs on landside slope (October 2018).

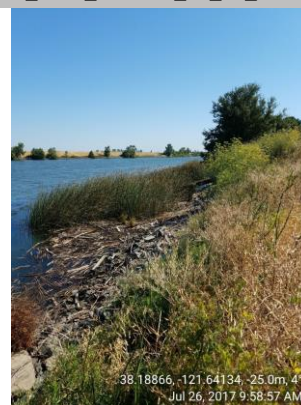
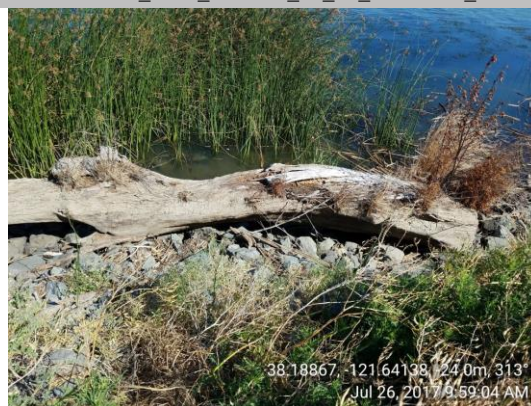
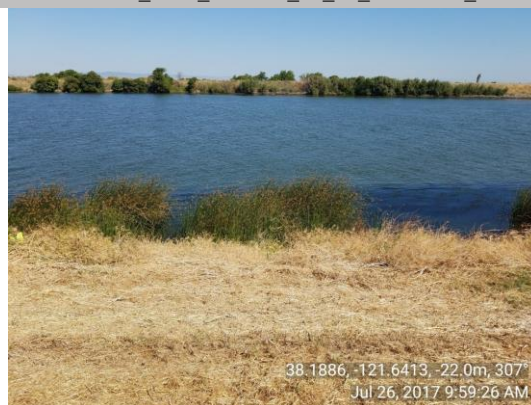
LM Start	10.15	Rating **	A/W	Issue No.	72
LM End	10.21	Issue Type +	Ma	Location *	
Category	Supplemental			GPS Latitude/Longitude	
				Start	End
Item	2017 Storm Damage			38.188431 °	38.187803 °
				-121.641703 °	-121.642478 °
DWR ID	DWR_RD0003_01_f_2017_72				
Comment Code					
Inspector Comment					
Levee Evaluation Comments					
Description:District station 536+35 to 539+47, Sec. 16, T. 4 N. R. 3 E., M.D.M. The waterside slope experienced sloughing and erosion along approximately 312 linear feet of Steamboat Slough (Unit 1). Sloughing commences at approximately 1/4 of the way down the slope from the crown and extends to the rip rap.					
Site ID No:277					
Site Designation:LMA-103					
Repair Type: Erosion					
Rating:Area of Concern					
Field Date:7/26/2017					
Notes:

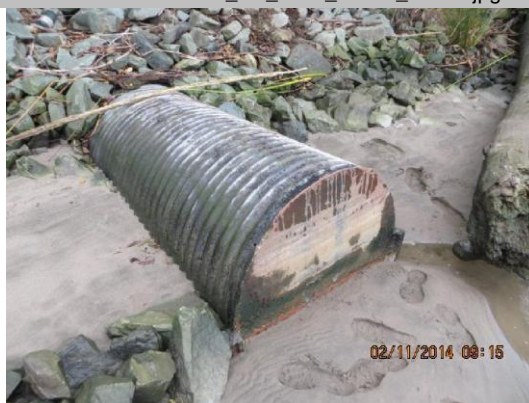
Photo 1 of 3 : UCIP\_SP\_2019\_29164\_53862.jpg

Comment Code					
Inspector Comment					
FS_ID:29164					
DS_ID:22349					
EP_NO: N/A					
Repair Type: Non-Urgent					
Crossing Status: Found					
UCIP Comments: Pipe appears abandoned and should be verified as having been filled with grout.					
FIELD_STRUCT_DESC: *ABANDONED* 2 of 3: 36-inch corrugated metal drainage pipe through the levee, 15 feet below the crown. Slide gate in a 48-inch corrugated metal pipe (CMP) riser on the waterside (WS) shoulder. Steel intake weir at the landside (LS) toe. Steel plate welded over the pipe on the WS toe. [Additional Reference(s): DWR Levee Log, 1993, referenced as 24 feet below the crown. USACE Sacramento O&M Manual 104, February 1960, (RM 15.20), referenced as invert elevation 24 feet below the crown].					
FS Date: 2/11/2014

Drainpipe visible on WS toe with steel plate welded over end.

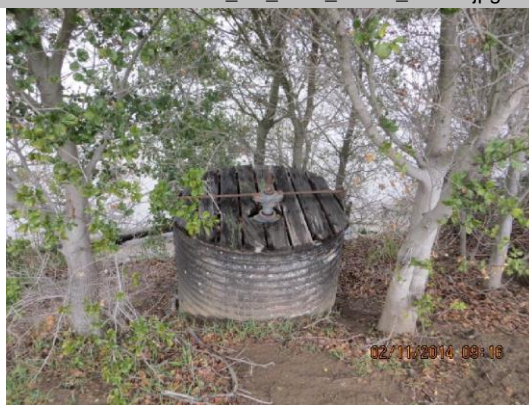
Photo 2 of 3 : UCIP\_SP\_2019\_29164\_53861.jpg

48-inch CMP riser with slide gate closed on WS shoulder.

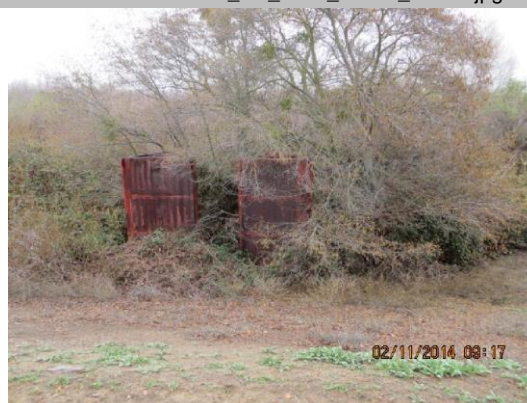
Photo 3 of 3 : UCIP\_SP\_2019\_29164\_53860.jpg

Steel weir on LS toe.

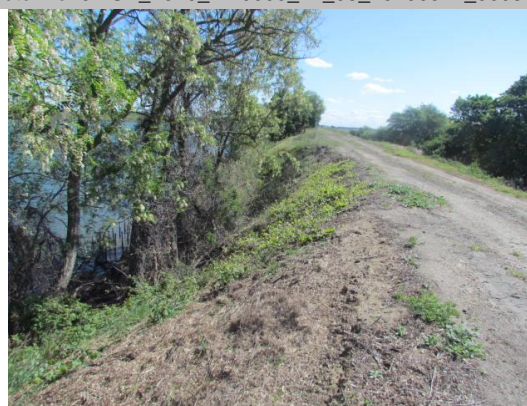
Photo 1 of 3 : SP\_2019\_RD0003\_24\_98\_20190311\_00086.jpg

LM Start	10.86	Rating **	A/W	Issue No.	98
LM End	10.89	Issue Type +	Ma	Location *	WS
Category	Earthen Levee			GPS Latitude/Longitude	
				Start	End
Item	Erosion / Bank Caving			38.182792 °	38.182672 °
				-121.652142 °	-121.652555 °
DWR ID	DWR_RD0003_01_s_2013_98				
Comment Code					
E2 : Schedule repair of erosion site prior to the next inspection.					
Inspector Comment					
Levee is extra wide in this section. Erosion is occurring outside the theoretical prism.

Looking north at erosion on waterward slope.

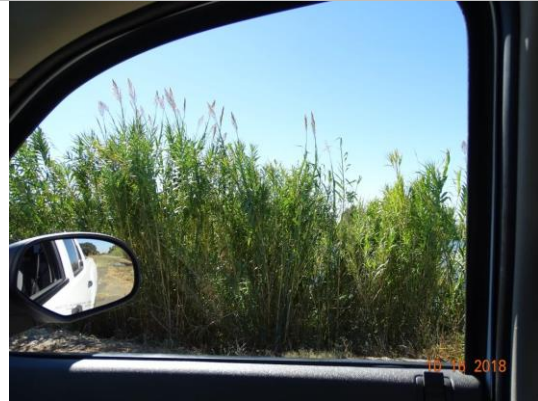
Photo 1 of 1 : SP\_2019\_RD0003\_25\_3\_20190311\_00004.jpg

LM Start	0.37	Rating **	U	Issue No.	3
LM End	0.37	Issue Type +	Ma	Location *	WS
Category	Earthen Levee			GPS Latitude/Longitude	
				Start	End
Item	Vegetation			38.174020 °	38.174020 °
				-121.647458 °	-121.647458 °
DWR ID	DWR_RD0003_02_f _ 2018_3				
Comment Code					
V2 : Remove the wild growth other than native grasses from the levee slopes.					
Inspector Comment					
Remove arundo from waterside slope.

View of arundo on waterside slope (October 2018).

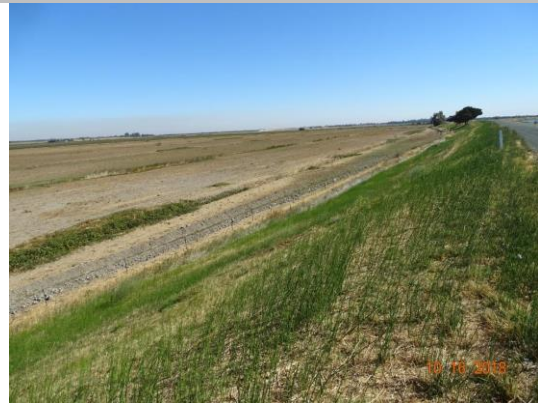
Photo 1 of 1 : SP\_2019\_RD0003\_25\_120\_20190311\_00083.jpg

LM Start	0.49	Rating **	M	Issue No.	120
LM End	0.84	Issue Type +	En	Location *	LS
Category	Earthen Levee			GPS Latitude/Longitude	
				Start	End
Item	Encroachments			38.173665 °	38.173525 °
				-121.645428 °	-121.639000 °
DWR ID	DWR_RD0003_02_f_2018_120				
Comment Code					
DT : Ditch					
Inspector Comment					
There is a ditch within 10' of the levee toe.

View looking upstream at temporary v-ditch at the edge of the landside toe (October 2018).

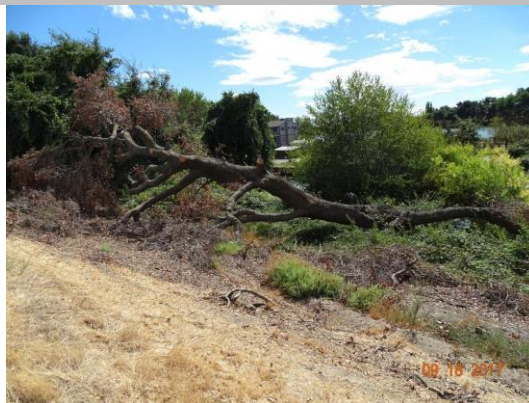
Photo 2 of 3 : SP\_2019\_RD0003\_25\_129\_20190311\_00092.jpg

LM Start	1.57	Rating **	M	Issue No.	129 (cont)	
LM End	1.57	Issue Type +	Ma	Location *	WS	
Category	Earthen Levee			GPS Latitude/Longitude		
				Start		End
Item	Encroachments			38.168700 °		38.168700 °
				-121.627233 °		-121.627233 °
DWR ID	DWR_RD0003_02_s_2017_129					
Comment Code						
TR : Tree or limb						
Inspector Comment						
Remove remaining branches and stump of downed tree from the waterside slope.

Looking east at waterside slope.

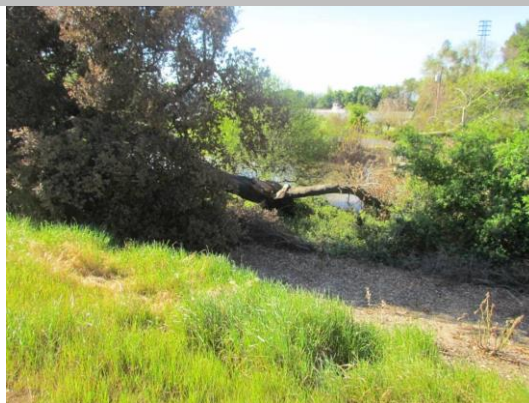
Photo 3 of 3 : SP\_2019\_RD0003\_25\_129\_20190311\_00093.jpg

Looking east at fallen tree on waterward slope.

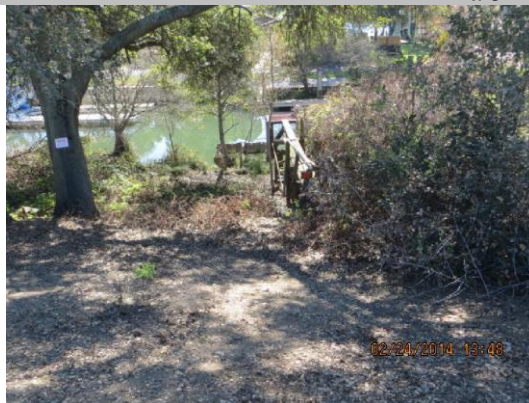
Photo 1 of 3 : UCIP\_SP\_2019\_31083\_56982.jpg

Comment Code					
Inspector Comment					
FS_ID:31083 DS_ID:22209 EP_NO: 1647 Repair Type: Non-Urgent Crossing Status: Found UCIP Comments: Sag in pavement over pipe on crown and wooden walkway to pump falling apart. Good candidate for video inspection. FIELD_STRUCT_DESC: 10-inch steel irrigation discharge pipe through the levee, invert elevation 5.8 feet below the crown. Pump on a pile structure in the channel. Service pole on the landside (LS) slope. 1.5-inch electrical conduit through the levee, 3 feet below the crown. 42-inch concrete standpipe at the LS toe. (Plans for installing a 1.5-inch electrical conduit through the levee authorized under Permit No. 1647, 1952 - Guiseppe and Emma D. Rosellini). [Additional References: DWR Levee Log, 1993. USACE Sacramento O&M Manual 104, February 1960, (RM 16.49)]. FS Date: 2/24/2014

Pump on pier on WS slope.

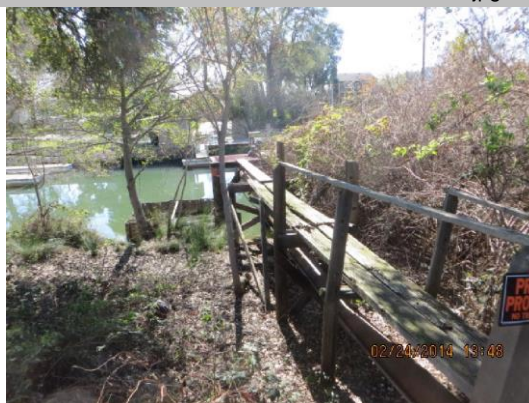
Photo 2 of 3 : UCIP\_SP\_2019\_31083\_56981.jpg

Pump on pier on WS slope. Wooden walkway failing.

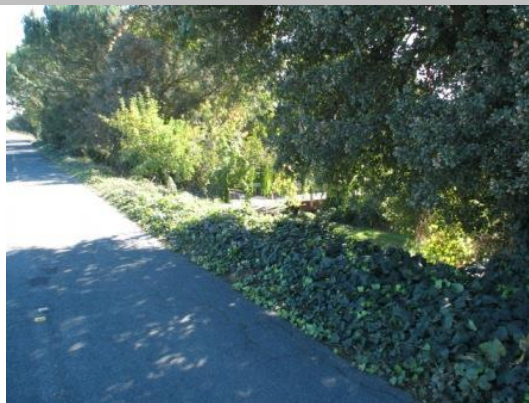
Photo 1 of 1 : SP\_2019\_RD0003\_25\_70\_20190311\_00045.jpg

LM Start	1.88	Rating **	U	Issue No.	70
LM End	1.93	Issue Type +	En	Location *	WS
Category	Earthen Levee			GPS Latitude/Longitude	
				Start	End
Item	Vegetation			38.166525 °	38.166176 °
				-121.622201 °	-121.621332 °
DWR ID	DWR_RD0003_02_s_2012_70				
Comment Code					
V6 : Landscaping					
Inspector Comment

Landscaping on levee slope obstructs visibility and access.

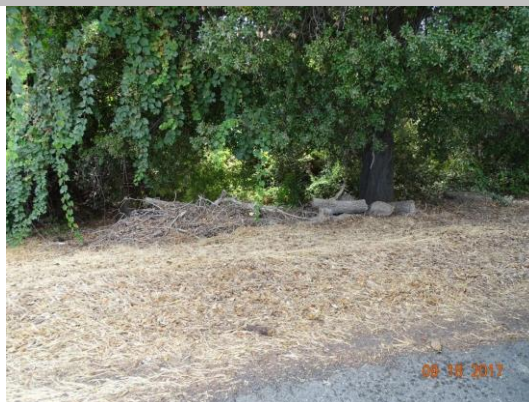
Photo 1 of 2 : SP\_2019\_RD0003\_25\_140\_20190311\_00110.jpg

LM Start	2.01	Rating **	M	Issue No.	140
LM End	2.01	Issue Type +	Ma	Location *	WS
Category	Earthen Levee			GPS Latitude/Longitude	
				Start	End
Item	Encroachments			38.165740 °	38.165740 °
				-121.619970 °	-121.619970 °
DWR ID	DWR_RD0003_02_f_2015_140				
Comment Code					
PR : Prunings					
Inspector Comment					
Remove pruning pile on waterside slope.

Looking south at the waterside slope.

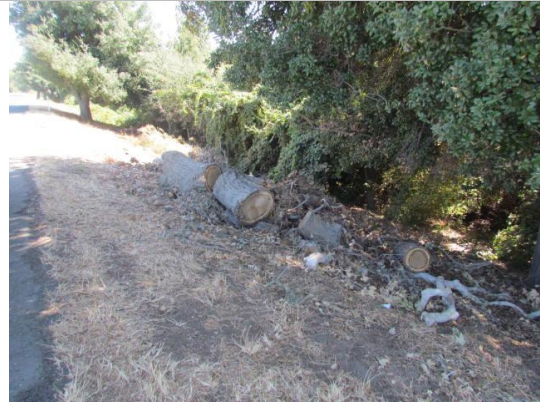
Photo 2 of 2 : SP\_2019\_RD0003\_25\_140\_20190311\_00111.jpg

LM Start	2.01	Rating **	M	Issue No.	140 (cont)	
LM End	2.01	Issue Type +	Ma	Location *	WS	
Category	Earthen Levee			GPS Latitude/Longitude		
				Start		End
Item	Encroachments			38.165740 °		38.165740 °
				-121.619970 °		-121.619970 °
DWR ID	DWR_RD0003_02_f_2015_140					
Comment Code						
PR : Prunings						
Inspector Comment						
Remove pruning pile on waterside slope.

Looking at tree branches and tree limbs on waterward shoulder and slope.

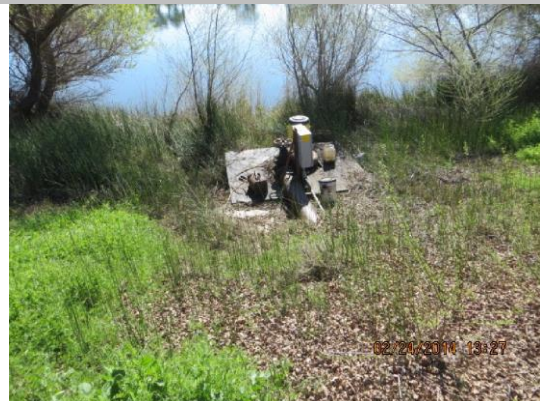
Photo 1 of 3 : UCIP\_SP\_2019\_31026\_56909.jpg

LM Start	2.39	Rating **	M	Issue No.	956	
LM End	2.39	Issue Type +	En	Location *		
Category	Supplemental			GPS Latitude/Longitude		
				Start	End	
Item	DWR UCIP Field Study			38.164366 °	38.164366 °	
				-121.613225 °	-121.613225 °	
DWR ID	22211

Comment Code						
Inspector Comment						
FS_ID:31026 DS_ID:22211 EP_NO: 2986 Repair Type: Non-Urgent Crossing Status: Found UCIP Comments: Trench over pipe on LS toe may indicate damage to pipe. Repair pipe and fill trench. FIELD_STRUCT_DESC: 12-inch steel irrigation discharge pipe through the levee, 5 feet below the crown. Pump and gate valve on the waterside (WS) slope. 42-inch concrete standpipe at the landside (LS) toe. 1.5-inch steel electrical conduit through the levee at the same location. (Plans for installation of a pumping plant on the levee authorized under Permit No. 2986, 1959 - Ike Craven). [Additional Reference(s): DWR Levee Log, 1993. USACE Sacramento O&M Manual 104, February 1960, (RM 17.25), referenced as invert elevation 4 feet below the crown]. FS Date: 2/24/2014

Pump, pipe, gate valve, and electrical conduit visible on WS slope.

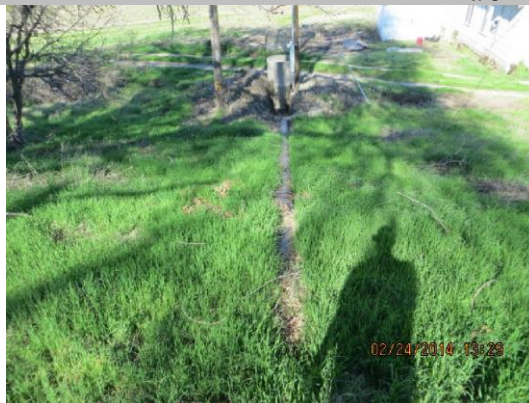
Photo 2 of 3 : UCIP\_SP\_2019\_31026\_56908.jpg

Comment Code						
Inspector Comment						
FS_ID:31026						
DS_ID:22211						
EP_NO: 2986						
Repair Type: Non-Urgent						
Crossing Status: Found						
UCIP Comments: Trench over pipe on LS toe may indicate damage to pipe. Repair pipe and fill trench.						
FIELD_STRUCT_DESC: 12-inch steel irrigation discharge pipe through the levee, 5 feet below the crown. Pump and gate valve on the waterside (WS) slope. 42-inch concrete standpipe at the landside (LS) toe. 1.5-inch steel electrical conduit through the levee at the same location. (Plans for installation of a pumping plant on the levee authorized under Permit No. 2986, 1959 - Ike Craven). [Additional Reference(s): DWR Levee Log, 1993. USACE Sacramento O&M Manual 104, February 1960, (RM 17.25), referenced as invert elevation 4 feet below the crown].						
FS Date: 2/24/2014

LM Start	<b>2.39</b>	Rating **	M	Issue No.	<b>956 (cont)</b>
LM End	<b>2.39</b>	Issue Type +	En	Location *

Pipe, meter, power pole, and concrete standpipe visible on LS slope/toe.

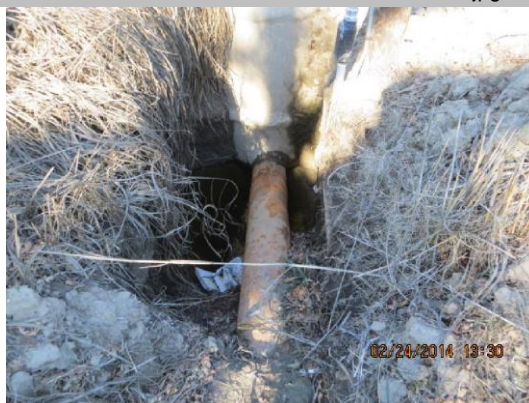
Photo 3 of 3 : UCIP\_SP\_2019\_31026\_56907.jpg

Trench excavated over pipe at Standpipe/LS toe.

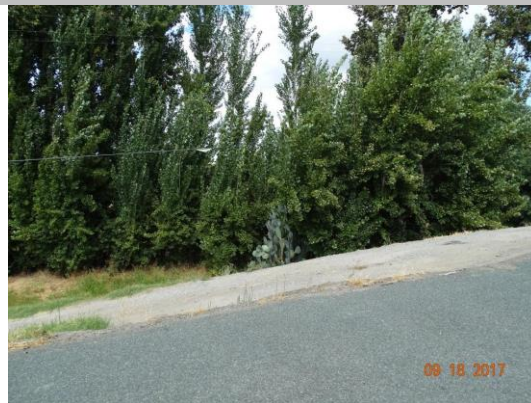
Photo 1 of 2 : SP\_2019\_RD0003\_25\_30\_20190311\_00024.jpg

LM Start	2.44	Rating **	M	Issue No.	30
LM End	2.44	Issue Type +	En	Location *	LS
Category	Earthen Levee			GPS Latitude/Longitude	
				Start	End
Item	Vegetation			38.164379 °	38.164379 °
				-121.612455 °	-121.612455 °
DWR ID	DWR_RD0003_02_f_2013_30				
Comment Code					
V6 : Landscaping					
Inspector Comment					
There is a cactus at the landside toe and berm.

Looking north at the landside slope.

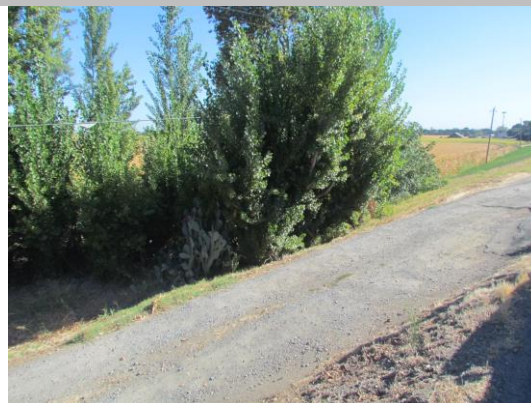
Photo 2 of 2 : SP\_2019\_RD0003\_25\_30\_20190311\_00025.jpg

LM Start	<b>2.44</b>	Rating **	M	Issue No.	<b>30 (cont)</b>
LM End	<b>2.44</b>	Issue Type +	En	Location *	LS

Looking northeast at cactus and untrimmed trees at landward toe.

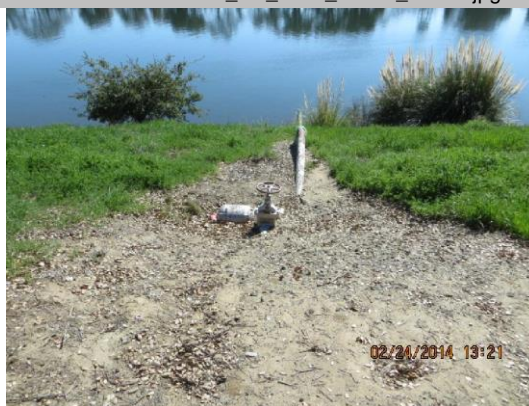
Photo 1 of 3 : UCIP\_SP\_2019\_31025\_56906.jpg

Comment Code					
Inspector Comment					
FS_ID:31025 DS_ID:22212 EP_NO: 1289 Repair Type: Non-Urgent Crossing Status: Indicator Found UCIP Comments: Appears abandoned and if so should be done so properly. FIELD_STRUCT_DESC: *ABANDONED* 6-inch steel irrigation discharge pipe through the levee, invert elevation 4.5 feet below the crown. Pump and gate valve on the waterside (WS) slope. Service pole on the landside (LS) with a 1.5-inch electrical conduit through the levee at the same location. (Plans for installing an irrigation pumping plant and a 6-inch steel pipe through the levee authorized under Permit No. 1289, 1948 - Carlos Silva). [Additional Reference(s): DWR Levee Log, 1993. USACE Sacramento O&M Manual 104, February 1960, (RM 17.56)]. FS Date: 2/24/2014

LM Start	<b>2.70</b>	Rating **	M	Issue No.	<b>957 (cont)</b>
LM End	<b>2.70</b>	Issue Type +	En	Location *

Pipe, pump, and gate valve on WS slope.

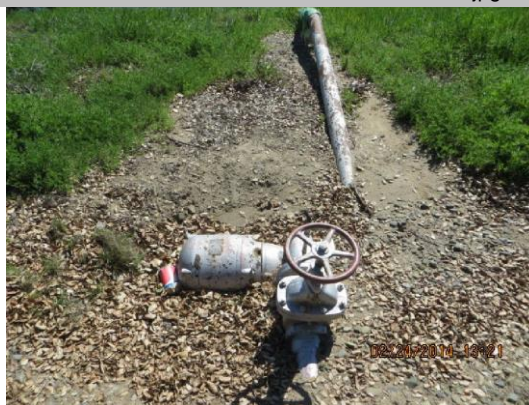
Photo 2 of 3 : UCIP\_SP\_2019\_31025\_56905.jpg

Pump and gate valve on WS slope.

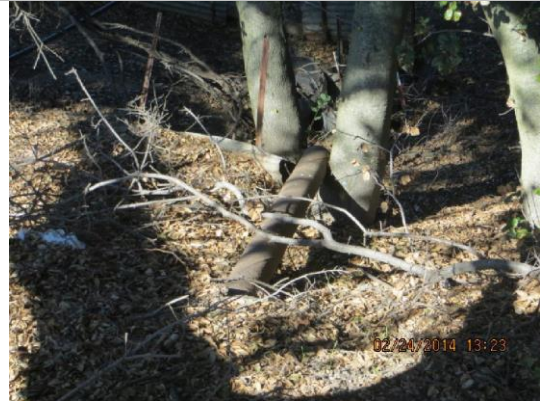
Photo 3 of 3 : UCIP\_SP\_2019\_31025\_56904.jpg

Comment Code						
Inspector Comment						
FS_ID:31025 DS_ID:22212 EP_NO: 1289 Repair Type: Non-Urgent Crossing Status: Indicator Found UCIP Comments: Appears abandoned and if so should be done so properly. FIELD_STRUCT_DESC: *ABANDONED* 6-inch steel irrigation discharge pipe through the levee, invert elevation 4.5 feet below the crown. Pump and gate valve on the waterside (WS) slope. Service pole on the landside (LS) with a 1.5-inch electrical conduit through the levee at the same location. (Plans for installing an irrigation pumping plant and a 6-inch steel pipe through the levee authorized under Permit No. 1289, 1948 - Carlos Silva). [Additional Reference(s): DWR Levee Log, 1993. USACE Sacramento O&M Manual 104, February 1960, (RM 17.56)]. FS Date: 2/24/2014

Pipe on LS slope.

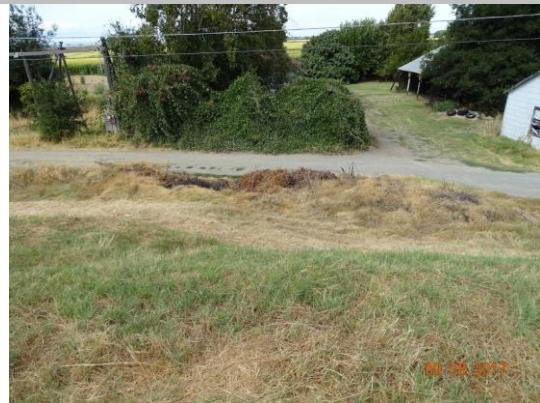
Photo 1 of 2 : SP\_2019\_RD0003\_25\_96\_20190311\_00072.jpg

LM Start	2.80	Rating **	M	Issue No.	96
LM End	2.80	Issue Type +	En	Location *	LS
Category	Earthen Levee			GPS Latitude/Longitude	
				Start	End
Item	Encroachments			38.164945 °	38.164945 °
				-121.605874 °	-121.605874 °
DWR ID	DWR_RD0003_02_f_2013_96				
Comment Code					
PR : Prunings					
Inspector Comment					
There are pruning piles at the landside toe.

Looking north at the landside slope.

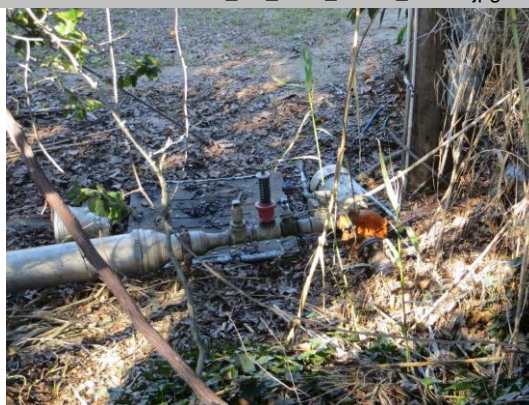
Photo 1 of 3 : UCIP\_SP\_2019\_30963\_56862.jpg

Comment Code						
Inspector Comment						
FS_ID:30963 DS_ID:22221 EP_NO: 1283 Repair Type: Non-Urgent Crossing Status: Indicator Found UCIP Comments: Permit for 12-inch pipe and pump on pier. Unable to identify permit for 6-inch pipe. FIELD_STRUCT_DESC: 12-inch steel irrigation discharge pipe through the levee, invert elevation 6 feet below the crown. Pump, shutoff valve, power pole, and vent at the landside (LS) toe. 6-inch steel pipe appears to be sleeved through the 12-inch pipe. 1.5-inch steel electrical conduit at the same location. (Plans for installing a pumping plant and a 12-inch pipe through the levee authorized under Permit No. 1283, 1948 - Manuel E. and Frank E. Silva). [Additional Reference(s): DWR Levee Log, 1993. USACE Sacramento O&M Manual 104, February 1960, (RM 18.66)]. FS Date: 2/24/2014

Pump, shutoff, power pole, and vent on LS toe.

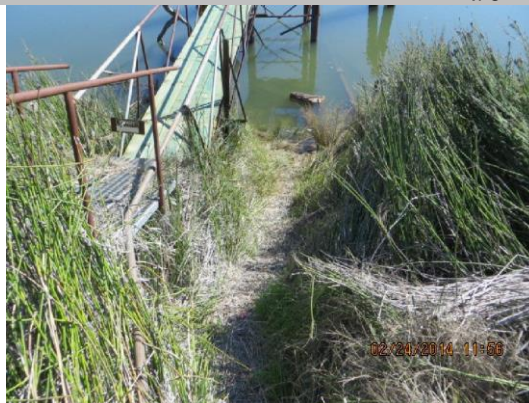
Photo 2 of 3 : UCIP\_SP\_2019\_30963\_56861.jpg

Comment Code						
Inspector Comment						
FS_ID:30963 DS_ID:22221 EP_NO: 1283 Repair Type: Non-Urgent Crossing Status: Indicator Found UCIP Comments: Permit for 12-inch pipe and pump on pier. Unable to identify permit for 6-inch pipe. FIELD_STRUCT_DESC: 12-inch steel irrigation discharge pipe through the levee, invert elevation 6 feet below the crown. Pump, shutoff valve, power pole, and vent at the landside (LS) toe. 6-inch steel pipe appears to be sleeved through the 12-inch pipe. 1.5-inch steel electrical conduit at the same location. (Plans for installing a pumping plant and a 12-inch pipe through the levee authorized under Permit No. 1283, 1948 - Manuel E. and Frank E. Silva). [Additional Reference(s): DWR Levee Log, 1993. USACE Sacramento O&M Manual 104, February 1960, (RM 18.66)]. FS Date: 2/24/2014

Pipe visible to right of walkway on LS slope and in water.

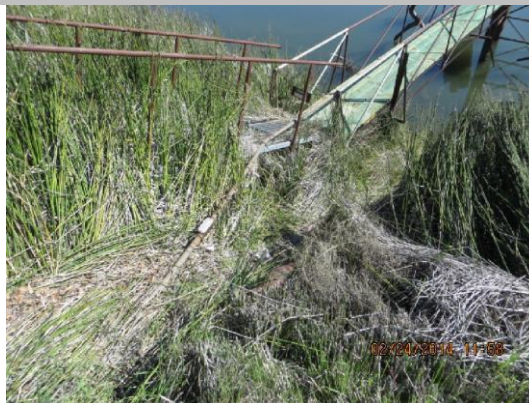
Photo 3 of 3 : UCIP\_SP\_2019\_30963\_56860.jpg

LM Start	<b>3.77</b>	Rating **	M	Issue No.	<b>959 (cont)</b>
LM End	<b>3.77</b>	Issue Type +	En	Location *

Pipe visible to right of walkway on LS slope.

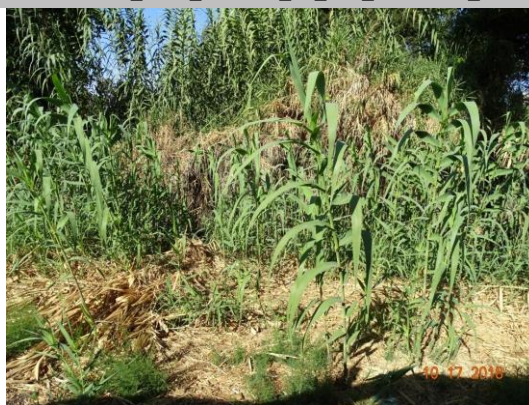
Photo 1 of 1 : SP\_2019\_RD0003\_25\_200\_20190311\_00157.jpg

LM Start	3.78	Rating **	U	Issue No.	200
LM End	3.78	Issue Type +	Ma	Location *	LS
Category	Earthen Levee			GPS Latitude/Longitude	
				Start	End
Item	Vegetation			38.174550 °	38.174550 °
				-121.593345 °	-121.593345 °
DWR ID	DWR_RD0003_02_f_2018_200				
Comment Code					
V2 : Remove the wild growth other than native grasses from the levee slopes.					
Inspector Comment					
Remove the new arundo growth.

View of new arundo growth on the landside slope (October 2018).

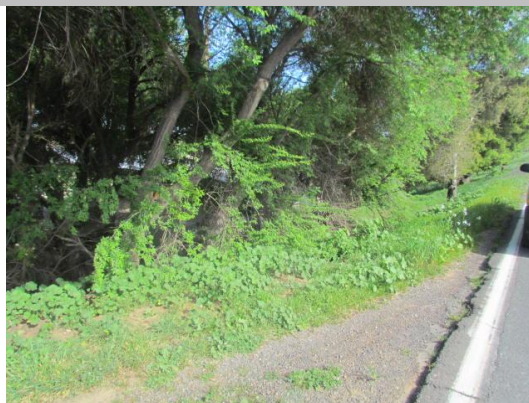
Photo 1 of 1 : SP\_2019\_RD0003\_25\_48\_20190311\_00034.jpg

LM Start	4.14	Rating **	M	Issue No.	48
LM End	4.14	Issue Type +	En	Location *	LS
Category	Earthen Levee			GPS Latitude/Longitude	
				Start	End
Item	Vegetation			38.179160 °	38.179160 °
				-121.590247 °	-121.590247 °
DWR ID	DWR_RD0003_02_f_2018_48				
Comment Code					
V6 : Landscaping					
Inspector Comment

Looking southwest at dense trees on landward slope.

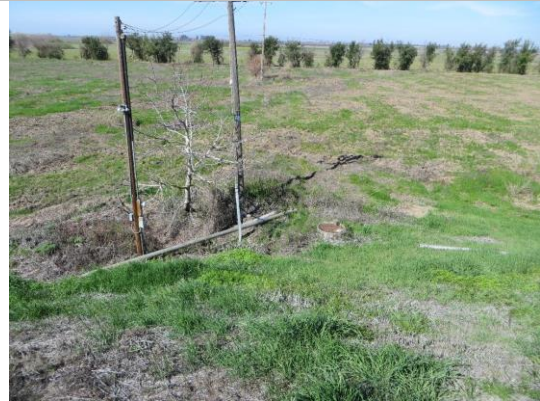
Photo 1 of 3 : UCIP\_SP\_2019\_53484\_56825.jpg

FS\_ID:53484  
DS\_ID:22224  
EP\_NO: N/A  
Repair Type: Non-Urgent  
Crossing Status: Found  
UCIP Comments: 07/20/2018 Everything appears to be the same as last time. Up and over pipe: low flood risk during high water. No integrity issues. Crossing downgraded to "Non-Urgent" because of the conditions listed above. (A. McDonald - DWR UCIP)07/06/2016 Same as last inspection. Open pipe on WS may be partially plugged. Unclear whether open pipe beneath pump platform connects to pump and crossing that rest above platform or if they are two separate crossings. If they are connected, positive closure device on pump may prevent backflow. Appears abandoned. (DWR UCIP - K. Fazel)02/24/2014 Pipe open on WS toe-visible under pump at WS toe. Pipe abandoned and should be done so properly. (DWR UCIP - G. Wylie)  
FIELD\_STRUCT\_DESC: \*ABANDONED\* 6-inch steel irrigation discharge pipe through the levee, 5.4 feet below the crown. Pipe visible beneath a pump platform on the waterside (WS). Another larger steel pipe (DSID 22223) visible through the WS slope and connected to a centrifugal pump with a closure valve resting over a platform on the WS. 2-inch electrical conduit through the levee at the same location leads to service pole on the landside (LS). [Additional Reference(s): DWR Levee Log, 1993. USACE Sacramento O&M Manual 104, February 1960 (RM 19.39)]. Levee Log mentions the 6-inch pipe is plugged and cut off.

Approximate location of pipe on LS toe.

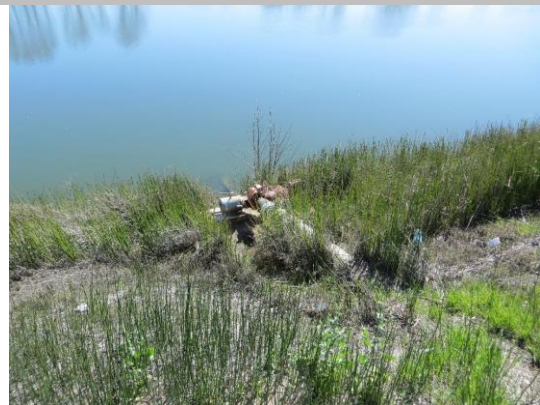
Photo 2 of 3 : UCIP\_SP\_2019\_53484\_56824.jpg

Pipe visible under pump on WS slope.

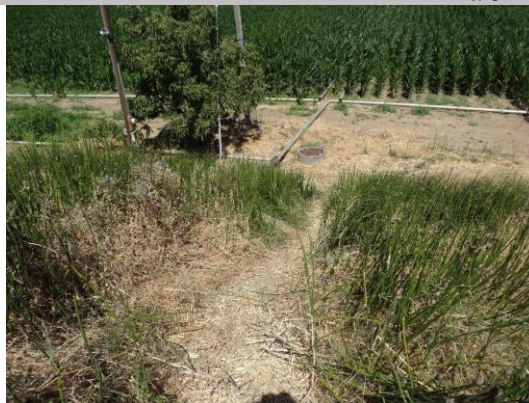
Photo 3 of 3 : UCIP\_SP\_2019\_53484\_75547.jpg

FS\_ID:53484  
DS\_ID:22224  
EP\_NO: N/A  
Repair Type: Non-Urgent  
Crossing Status: Found  
UCIP Comments: 07/20/2018 Everything appears to be the same as last time. Up and over pipe: low flood risk during high water. No integrity issues. Crossing downgraded to "Non-Urgent" because of the conditions listed above. (A. McDonald - DWR UCIP)07/06/2016 Same as last inspection. Open pipe on WS may be partially plugged. Unclear whether open pipe beneath pump platform connects to pump and crossing that rest above platform or if they are two separate crossings. If they are connected, positive closure device on pump may prevent backflow. Appears abandoned. (DWR UCIP - K. Fazel)02/24/2014 Pipe open on WS toe-visible under pump at WS toe. Pipe abandoned and should be done so properly. (DWR UCIP - G. Wylie)  
FIELD\_STRUCT\_DESC: \*ABANDONED\* 6-inch steel irrigation discharge pipe through the levee, 5.4 feet below the crown. Pipe visible beneath a pump platform on the waterside (WS). Another larger steel pipe (DSID 22223) visible through the WS slope and connected to a centrifugal pump with a closure valve resting over a platform on the WS. 2-inch electrical conduit through the levee at the same location leads to service pole on the landside (LS). [Additional Reference(s): DWR Levee Log, 1993. USACE Sacramento O&M Manual 104, February 1960 (RM 19.39)]. Levee Log mentions the 6-inch pipe is plugged and cut off.

LS view; standpipe and power pole off LS toe.

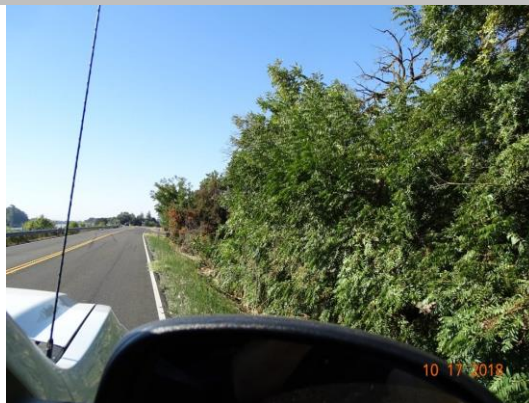
Photo 1 of 1 : SP\_2019\_RD0003\_25\_199\_20190311\_00156.jpg

LM Start	4.63	Rating **	U	Issue No.	199
LM End	4.66	Issue Type +	En	Location *	LS
Category	Earthen Levee			GPS Latitude/Longitude	
				Start	End
Item	Vegetation			38.185122 °	38.185430 °
				-121.585165 °	-121.584835 °
DWR ID	DWR_RD0003_02_f_2018_199				
Comment Code					
V6 : Landscaping					
Inspector Comment

View looking downstream at landscaping on the landside slope (October 2018).

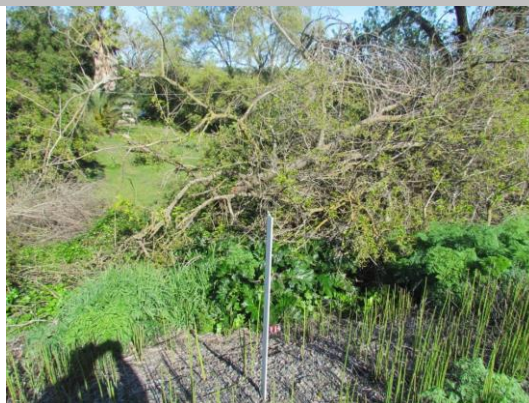
Photo 1 of 1 : SP\_2019\_RD0003\_25\_97\_20190311\_00074.jpg

LM Start	4.65	Rating **	U	Issue No.	97
LM End	4.65	Issue Type +	Ma	Location *	LS
Category	Earthen Levee			GPS Latitude/Longitude	
				Start	End
Item	Encroachments			38.185317 °	38.185317 °
				-121.584870 °	-121.584870 °
DWR ID	DWR_RD0003_02_s_2017_97				
Comment Code					
TR : Tree or limb					
Inspector Comment					
There is a fallen tree on the landside slope.

Looking west at fallen tree on landward slope.

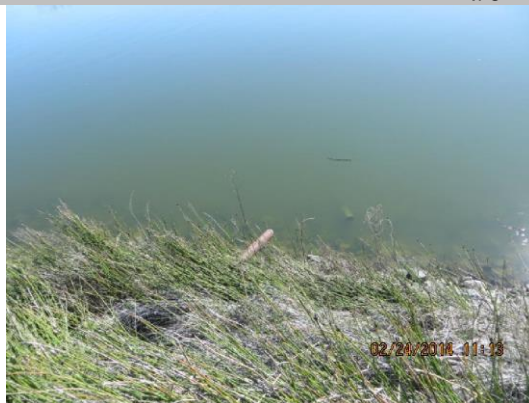
Photo 1 of 2 : UCIP\_SP\_2019\_30903\_56801.jpg

LM Start	4.74	Rating **	M	Issue No.	961
LM End	4.74	Issue Type +	En	Location *	
Category	Supplemental			GPS Latitude/Longitude	
				Start	End
Item	DWR UCIP Field Study			38.186292 °	38.186292 °
				-121.583945 °	-121.583945 °
DWR ID	22227				
Comment Code					
Inspector Comment					
FS_ID:30903 DS_ID:22227 EP_NO: N/A Repair Type: Non-Urgent Crossing Status: Found UCIP Comments: Need to verify type of abandonment. Does not appear to have been abandoned properly. FIELD_STRUCT_DESC: *ABANDONED* 5-inch steel gravity irrigation pipe through the levee, invert elevation 3.4 feet below the crown. (J. del Costello). [Additional Reference(s): DWR Levee Log, 1993. USACE Sacramento O&M Manual 104, February 1960, (RM 19.63)]. FS Date: 2/24/2014

Pipe visible at WS toe.

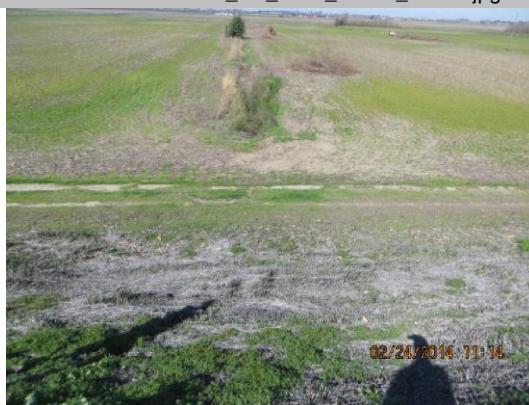
Photo 2 of 2 : UCIP\_SP\_2019\_30903\_56800.jpg

Swale off LS toe likely along same alignment as pipe.

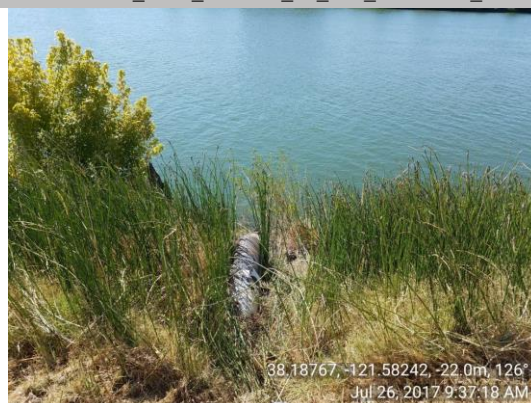
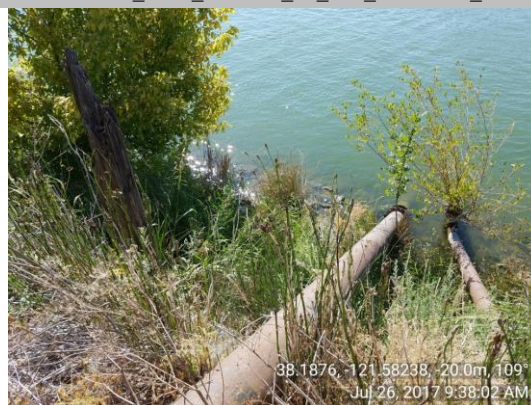
LM Start	4.86	Rating **	A/W	Issue No.	127
LM End	4.87	Issue Type +	Ma	Location *	
Category	Supplemental			GPS Latitude/Longitude	
				Start	End
Item	2017 Storm Damage			38.187528 °	38.187781 °
				-121.582394 °	-121.582331 °
DWR ID	DWR_RD0003_02_f_2017_127				
Comment Code					
Inspector Comment					
Levee Evaluation Comments					
Description:District station 256+60 to 257+96, Sec. 19, T. 4 N. R. 4 E., M.D.M. Approximately 136 linear feet erosion and sloughing exists along the water side slope of the Sacramento River (Unit 2). The erosion commences approximately 1/4 of the way down the slope from the crown and extends to the rip rap.					
Site ID No:278					
Site Designation:LMA-104					
Repair Type: Erosion					
Rating:Area of Concern					
Field Date:7/26/2017					
Notes:

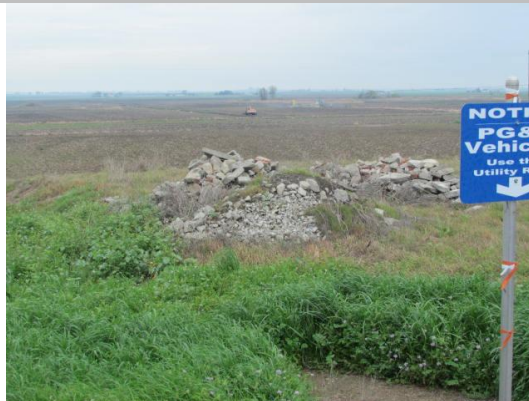
Photo 1 of 2 : SP\_2019\_RD0003\_25\_76\_20190311\_00050.jpg

LM Start	5.35	Rating **	M	Issue No.	76
LM End	5.35	Issue Type +	En	Location *	LS
Category	Earthen Levee			GPS Latitude/Longitude	
				Start	End
Item	Encroachments			38.191392 °	38.191392 °
				-121.574832 °	-121.574832 °
DWR ID	DWR_RD0003_02_s_2013_76				
Comment Code					
MA : Material					
Inspector Comment					
There is concrete rubble on the landside slope.

Looking northwest at concrete rubble on landward slope.

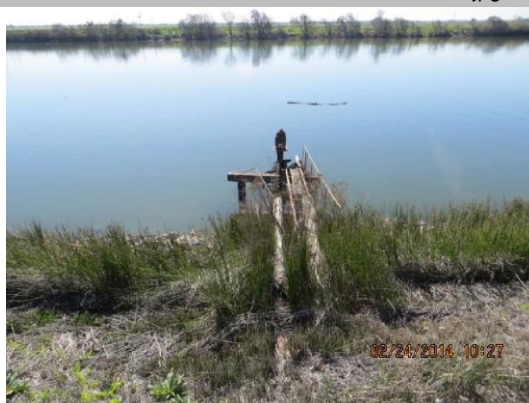
Photo 2 of 3 : UCIP\_SP\_2019\_41643\_56792.jpg

Pump on pier at WS toe.

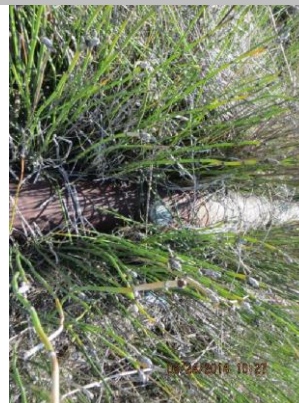
Photo 3 of 3 : UCIP\_SP\_2019\_41643\_56791.jpg

Siphon breaker on WS shoulder.

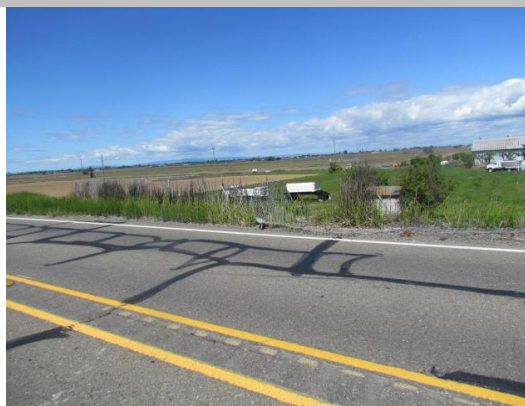
Photo 1 of 1 : SP\_2019\_RD0003\_25\_21\_20190311\_00022.jpg

LM Start	5.53	Rating **	M	Issue No.	21
LM End	5.56	Issue Type +	En	Location *	LS
Category	Earthen Levee			GPS Latitude/Longitude	
				Start	End
Item	Encroachments			38.192358 °	38.192458 °
				-121.571742 °	-121.571320 °
DWR ID	DWR_RD0003_02_s_2012_21				
Comment Code					
FE : Fence					
Inspector Comment					
There is a fence on the landside shoulder.

Looking west at cyclone fence on landward shoulder.

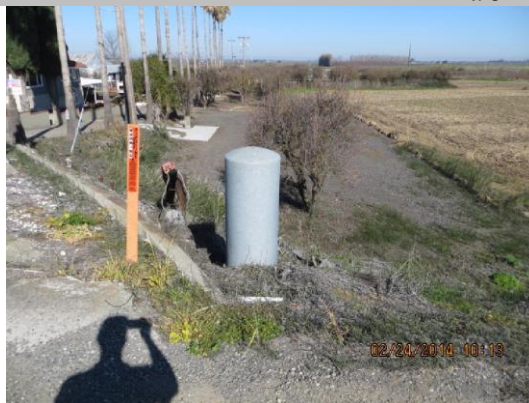
Photo 1 of 3 : UCIP\_SP\_2019\_40542\_56797.jpg

LM Start	5.59	Rating **	M	Issue No.	963
LM End	5.59	Issue Type +	En	Location *	
Category	Supplemental			GPS Latitude/Longitude	
				Start	End
Item	DWR UCIP Field Study			38.192581 °	38.192581 °
				-121.570807 °	-121.570807 °
DWR ID	22233				
Comment Code					
Inspector Comment					
FS_ID:40542 DS_ID:22233 EP_NO: 1311 Repair Type: Non-Urgent Crossing Status: Found UCIP Comments: Systed appears abandoned and if so, should be done so properly. FIELD_STRUCT_DESC: 2-inch galvanized iron domestic water line through the levee, 4 feet below the crown. Hand pump and pump on the waterside (WS) slope. Tank on the landside (LS) shoulder. (Plans for installing three pipes through the levee authorized under Permit No. 1311, 1948 - Joe Lopes). [Additional Reference(s): DWR Levee Log, 1993]. FS Date: 2/24/2014

Tank on LS shoulder.

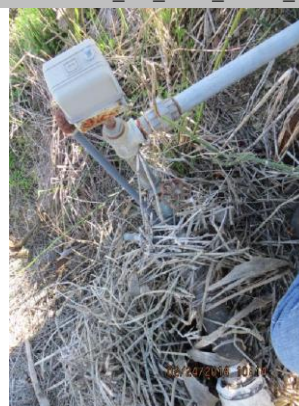
Photo 2 of 3 : UCIP\_SP\_2019\_40542\_56796.jpg

LM Start	5.59	Rating **	M	Issue No.	963 (cont)	
LM End	5.59	Issue Type +	En	Location *		
Category	Supplemental			GPS Latitude/Longitude		
				Start		End
Item	DWR UCIP Field Study			38.192581 °		38.192581 °
				-121.570807 °		-121.570807 °
DWR ID	22233					
Comment Code						
Inspector Comment						
FS_ID:40542 DS_ID:22233 EP_NO: 1311 Repair Type: Non-Urgent Crossing Status: Found UCIP Comments: Systed appears abandoned and if so, should be done so properly. FIELD_STRUCT_DESC: 2-inch galvanized iron domestic water line through the levee, 4 feet below the crown. Hand pump and pump on the waterside (WS) slope. Tank on the landside (LS) shoulder. (Plans for installing three pipes through the levee authorized under Permit No. 1311, 1948 - Joe Lopes). [Additional Reference(s): DWR Levee Log, 1993]. FS Date: 2/24/2014

Valve next to tank on LS shoulder.

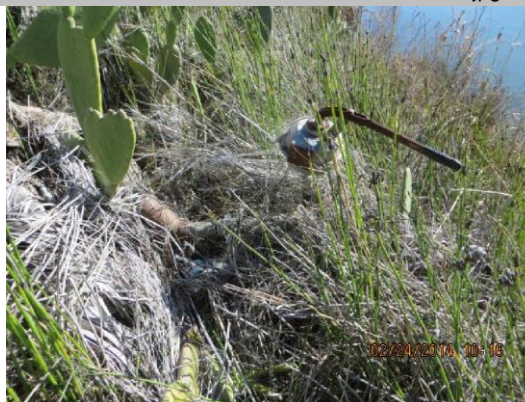
Photo 3 of 3 : UCIP\_SP\_2019\_40542\_56795.jpg

Hand pump and electric pump on WS slope.

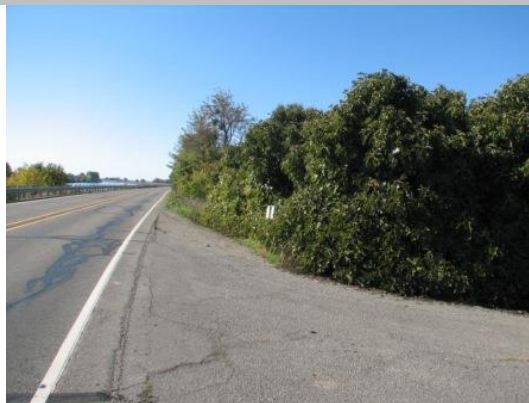
Photo 1 of 2 : SP\_2019\_RD0003\_25\_11\_20190311\_00011.jpg

LM Start	5.81	Rating **	U	Issue No.	11
LM End	5.86	Issue Type +	En	Location *	LS
Category	Earthen Levee			GPS Latitude/Longitude	
				Start	End
Item	Vegetation			38.193552 °	38.193832 °
				-121.566933 °	-121.565995 °
DWR ID	DWR_RD0003_02_s_2012_11				
Comment Code					
V6 : Landscaping					
Inspector Comment

Landscaping on levee slope and toe obstructs access and visibility.

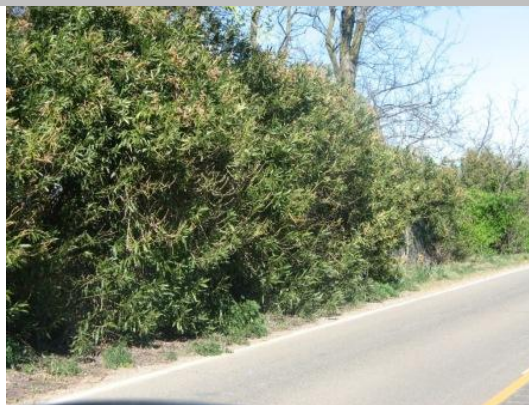
Photo 2 of 2 : SP\_2019\_RD0003\_25\_11\_20190311\_00012.jpg

Oleander on landside shoulder blocking view of levee slope from LM 5.81 to 5.86

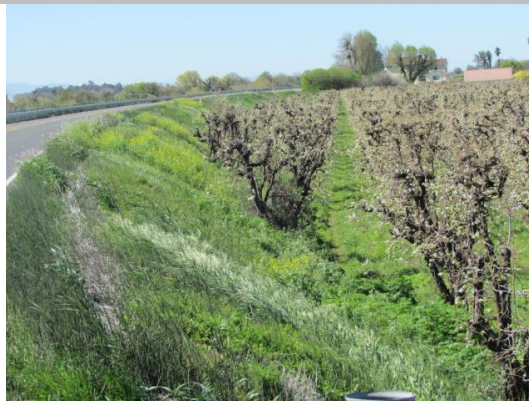
Photo 1 of 1 : SP\_2019\_RD0003\_25\_54\_20190311\_00037.jpg

LM Start	5.98	Rating **	M	Issue No.	54
LM End	6.08	Issue Type +	En	Location *	LS
Category	Earthen Levee			GPS Latitude/Longitude	
				Start	End
Item	Encroachments			38.194705 °	38.195586 °
				-121.564116 °	-121.562669 °
DWR ID	DWR_RD0003_02_s_2012_54				
Comment Code					
CR : Crops					
Inspector Comment					
There is an orchard on the lower levee slope.

Looking south at trees on landward toe.

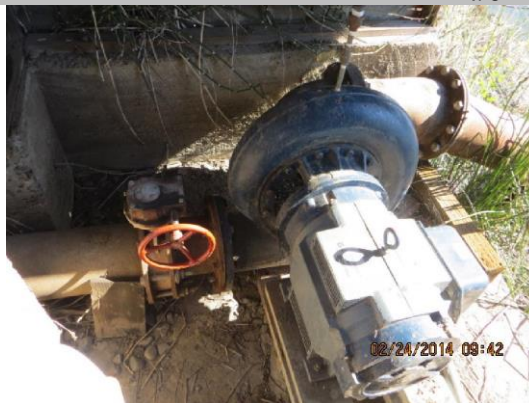
Photo 1 of 3 : UCIP\_SP\_2019\_30864\_56747.jpg

Comment Code						
Inspector Comment						
FS_ID:30864 DS_ID:22238 EP_NO: 9430 Repair Type: Non-Urgent Crossing Status: Found UCIP Comments: Annular space not grouted. FIELD_STRUCT_DESC: 12-inch steel irrigation discharge pipe through the levee, invert elevation 4 feet below the crown. 8-inch pipe sleeved through the 12-inch pipe. Pump and gate valve in a pump house and a vent on the waterside (WS) slope. Siphon breaker in a 16-inch corrugated metal pipe (CMP) riser on the landside (LS) shoulder. 4-foot concrete standpipe, power pole, and meter on the LS toe. (Retention of an irrigation pumping plant with a centrifugal pump and accessories in a corrugated metal shed on the WS slope above rock authorized under Automatic Board Order (ABO) issued as Permit No. 9430, 1974 - M. B. Millhauser). [Additional Reference(s): DWR Levee Log, 1993. USACE Sacramento O&M Manual 104, February 1960, (RM 20.99)]. FS Date: 2/24/2014

Pump and gate valve inside pumphouse on WS slope.
